PCBs Concrete and Soil Sampling Cleanup Verification Work Plan and Sampling and Analytical Plan

North Campus Student Housing - McCarty Hall
University of Washington
Seattle, King County, Washington

January 15, 2016
UW Project No. 204350
Terracon Project No. BA158014

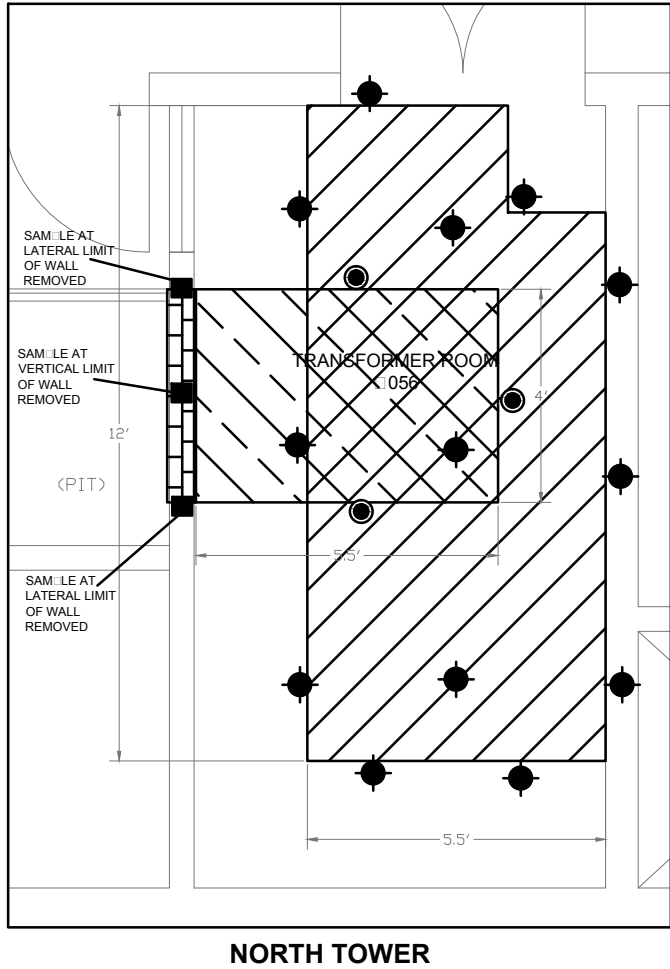
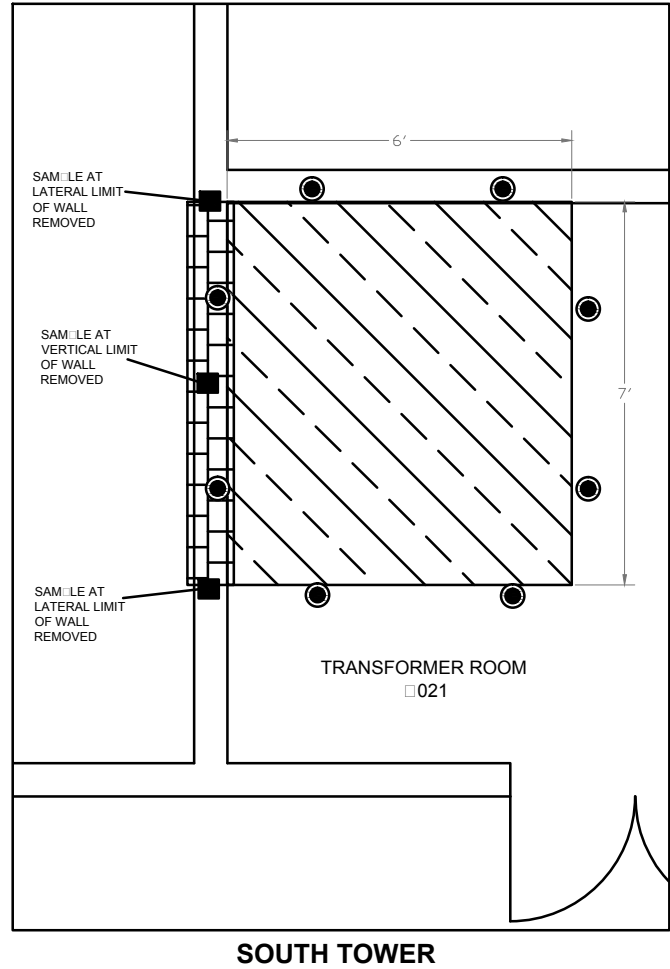
Exhibit 2: PCB Cleanup Verification Sample Plan

- REMOVE SOIL ONLY TO 24 INCHES BELOW SLAB
- REMOVE CONCRETE SLAB ONLY
- REMOVE LOWER 12 INCHES OF CMU WALL BLOCK ONLY

Following excavation and removal of the PCBs-impacted soil areas shown in the Central and North towers on Exhibit 2, discrete soil samples will be collected for laboratory analysis from the excavation bottom and sidewalls using a clean stainless steel hand shovel. In the North tower, two discrete samples will be collected from the East and West sidewall of the excavation, and three from the North and South sidewall and the excavation bottom to be composited into one sample per sidewall (e.g. North, South, East and West) and pit bottom. Due to the size of the PCBs-impacted soil area in the Central tower, one discrete soil sample will be collected from the East and West sidewall and submitted along with two discrete

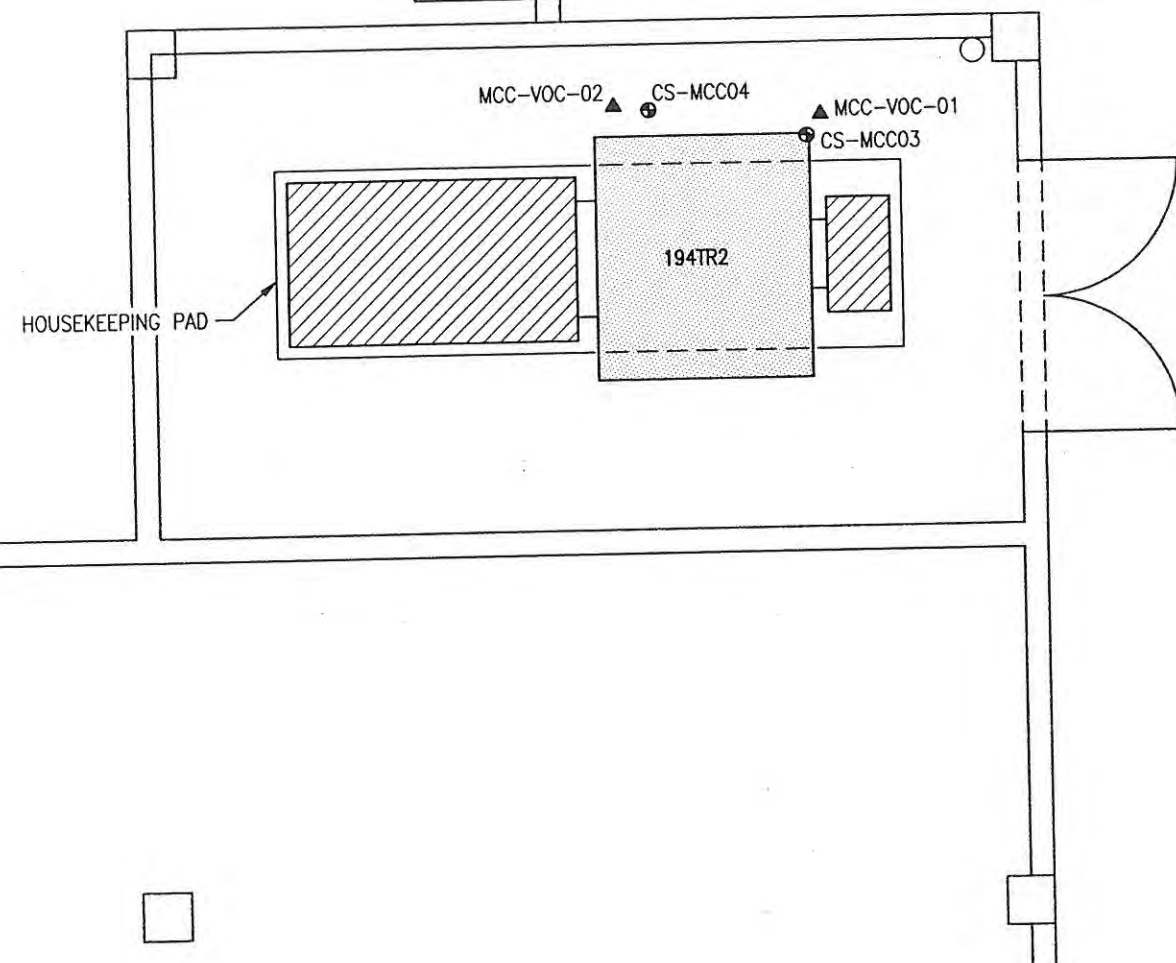
University of Washington
Seattle, Washington
Figure C2

VOC SITE CHARACTERIZATION SAMPLE LOCATIONS - McCARTY HALL, CENTRAL ROOM
